Inspection Report

111 Sample Dr.
Anytown, TX

JMJ Home Inspections

Date: 7/21/2015	Time: 9:00 AM	Report ID: Sample
Property: 111 Sample Dr. Canyon Lake TX	Customer: Joe Homebuyer	Real Estate Professional: Mary Realtor

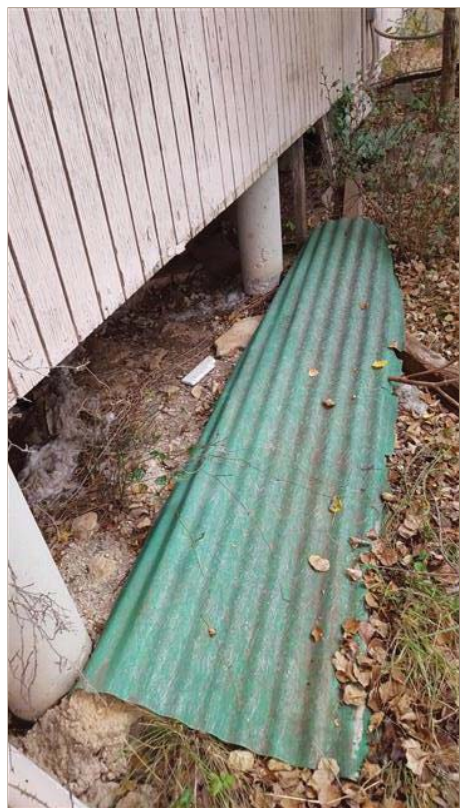
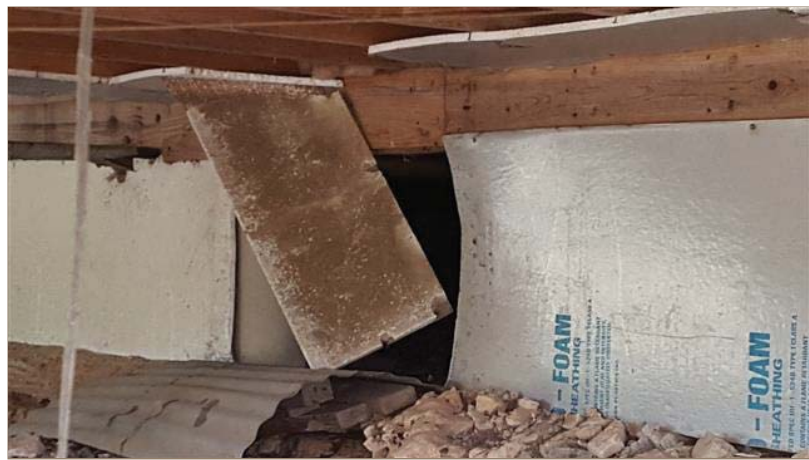
(2) Skirting around house has come loose and needs to be replaced to help with energy efficiency and to prevent pest habitation.

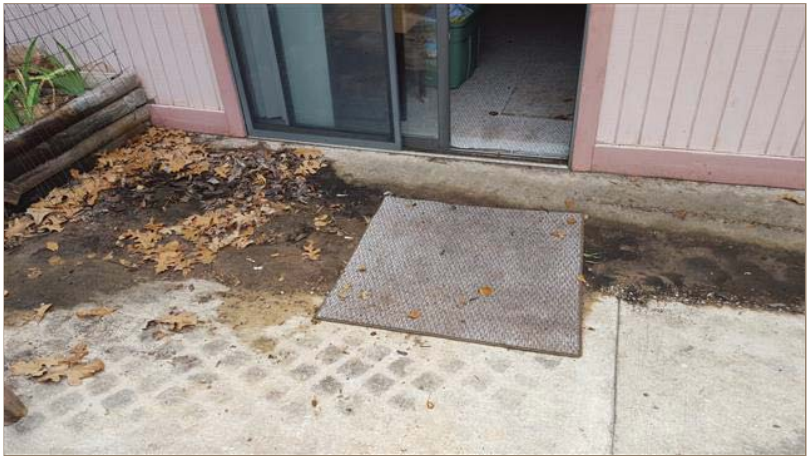
(1) Driveway is sloped toward the house. During heavy rains it appears that water intrusion has occurred to the left of the sliding glass door.

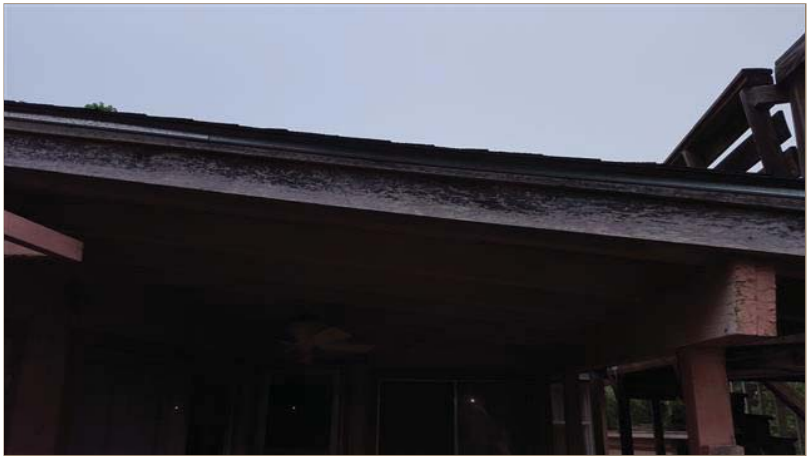
- (1) Note: The roof covering is in good condition without significant observable defects. The roof covering appears to be performing consistent with accepted industry standards with consideration of its age.
- (2) Eaves around the house need to be cleaned and painted.

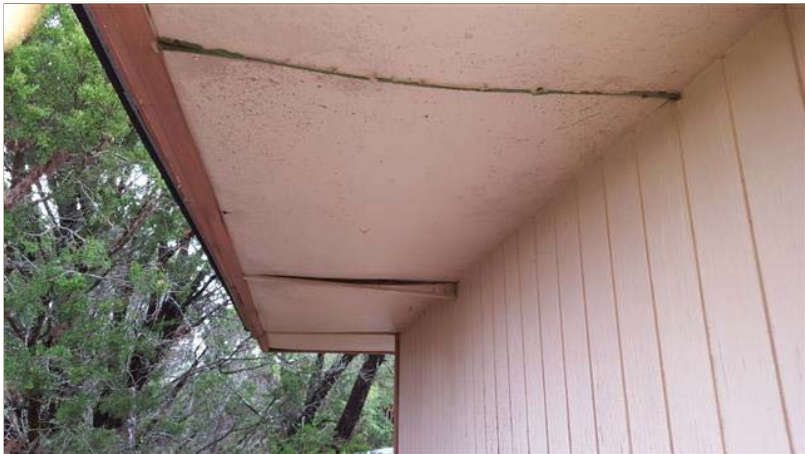
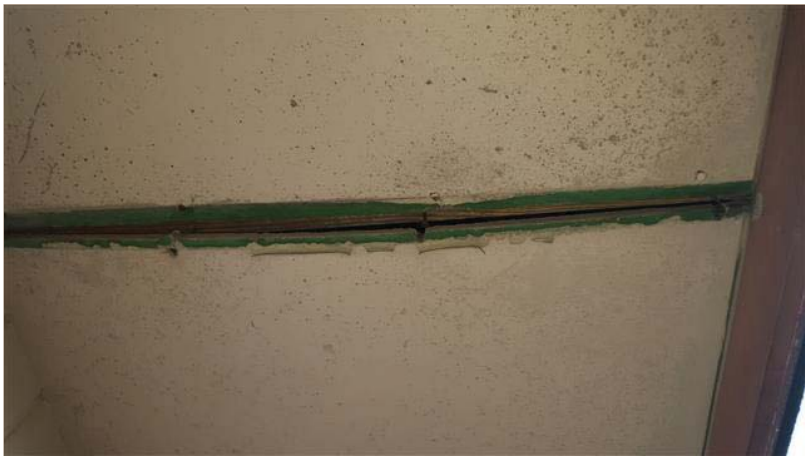
(3) Eaves in several locations around the perimeter of the house are coming loose and need to be secured.

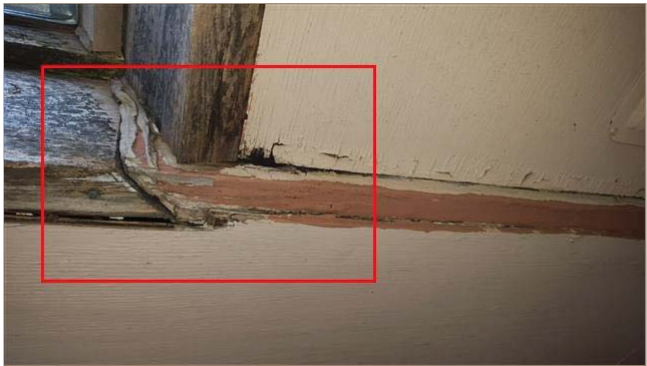
(4) Minor wood rot at back of house at corner of addition next to the master bedroom needs to be repaired.

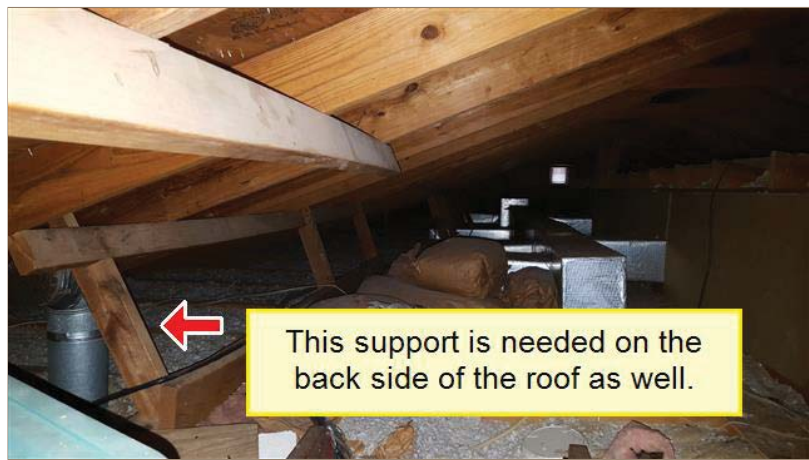
(1) Rafters on back side of roof structure span a distance of greater than 12 feet and need additional support to prevent sagging of the rafters.

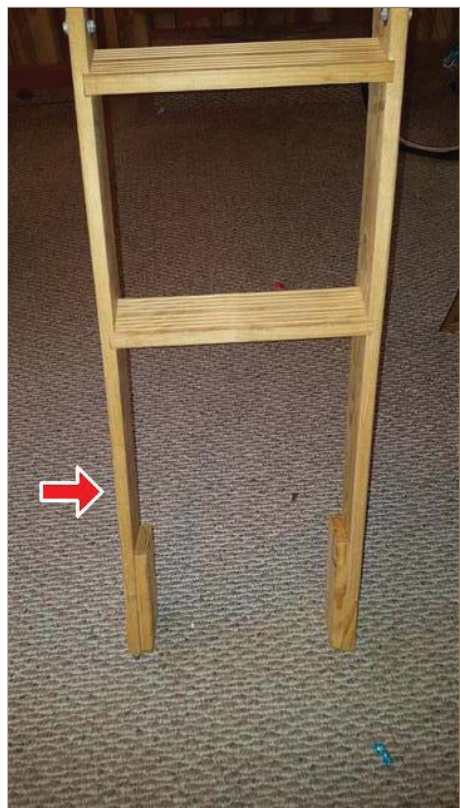
(2) The lowest step is missing from the attic stairs.

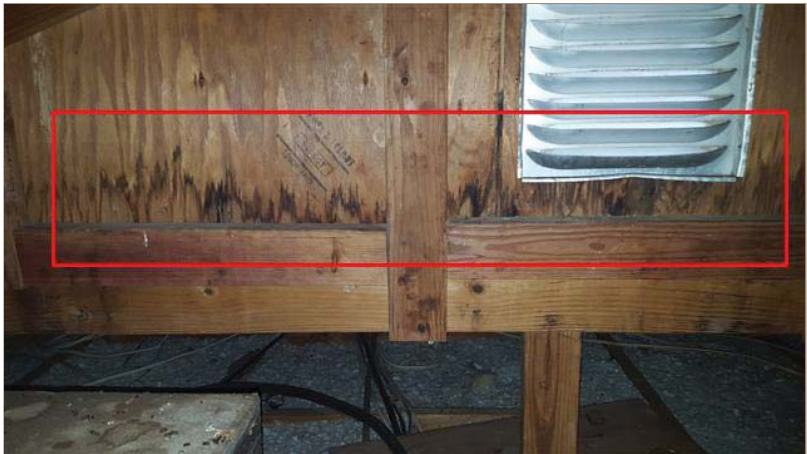
(3) Water damage on attic wall on left side of house likely caused by poor caulking and rain entering in through gable vent.

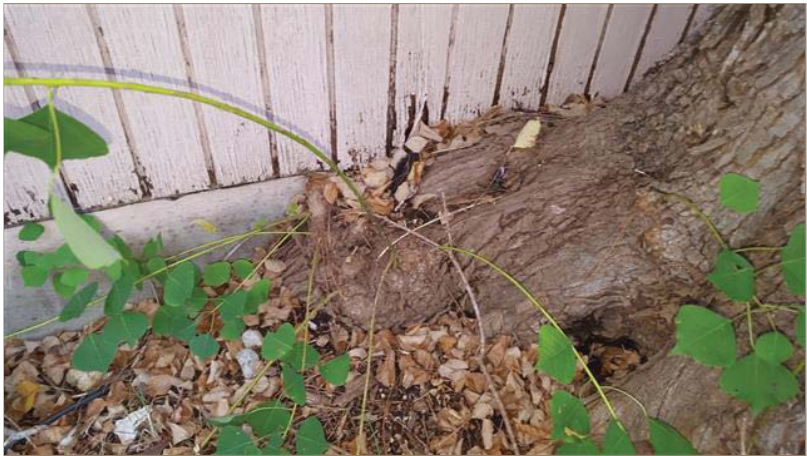
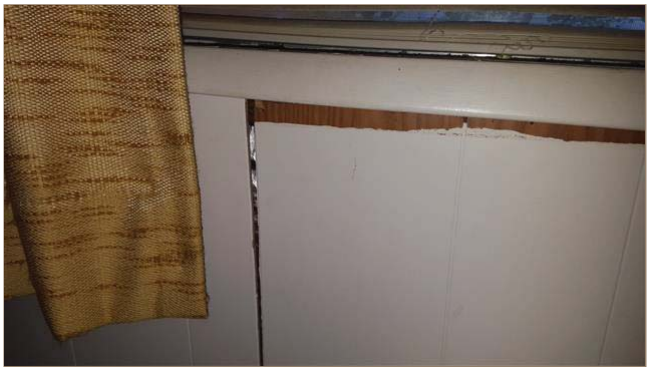
(1) Chinaberry tree is too close to the house and is lifting the foundation footer causing damage to front bedroom floor and walls.

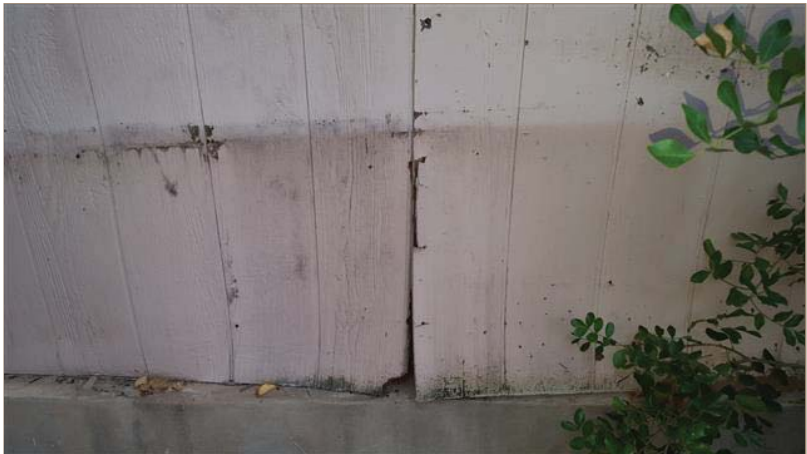
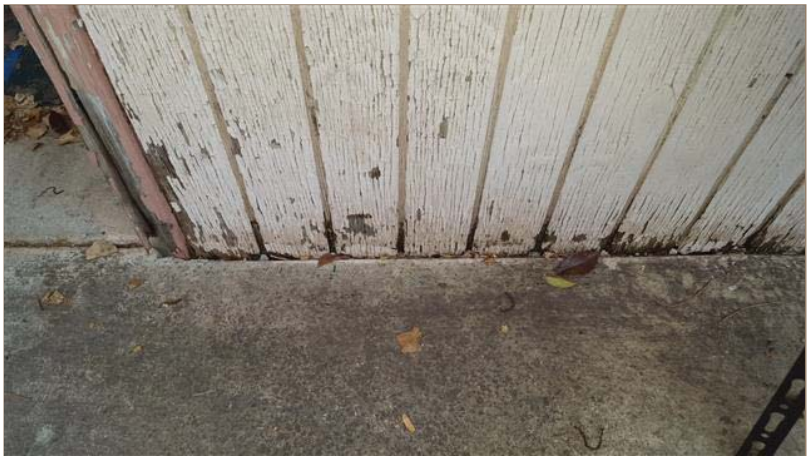
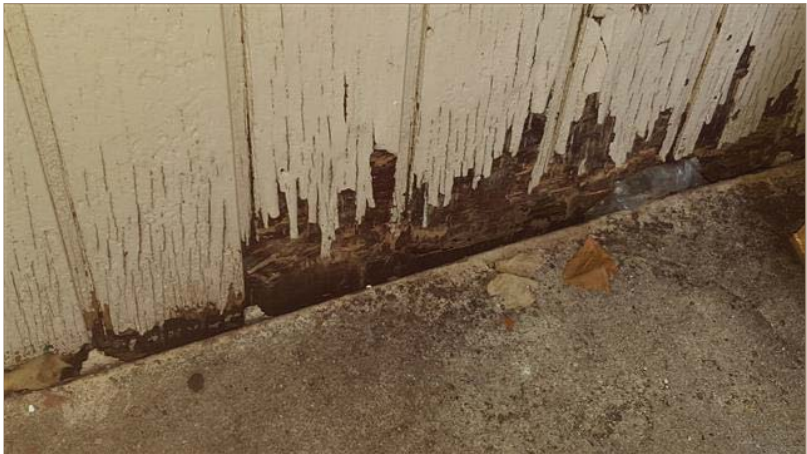
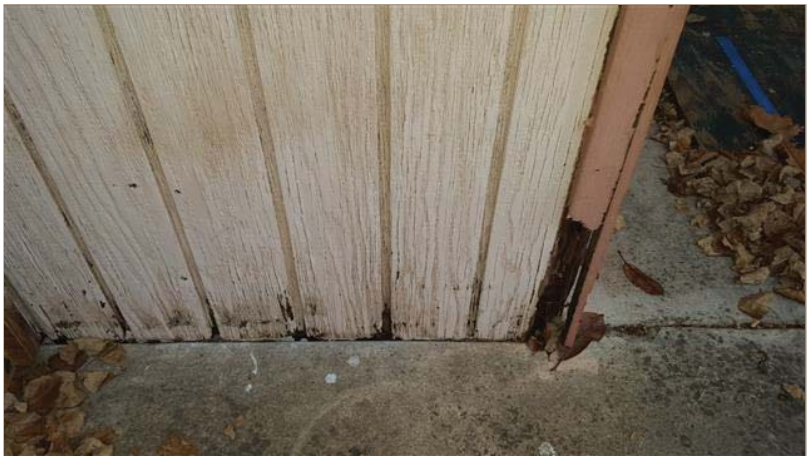
(2) Base of siding in places throughout the exterior of the house are water damaged and need to be repaired or replaced.

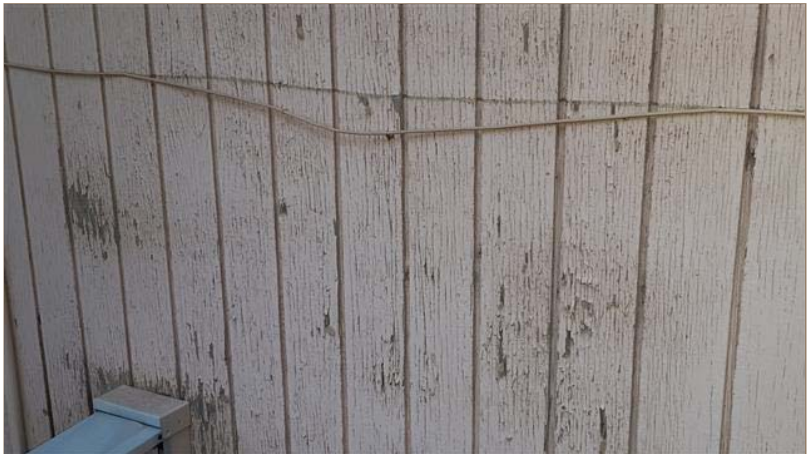
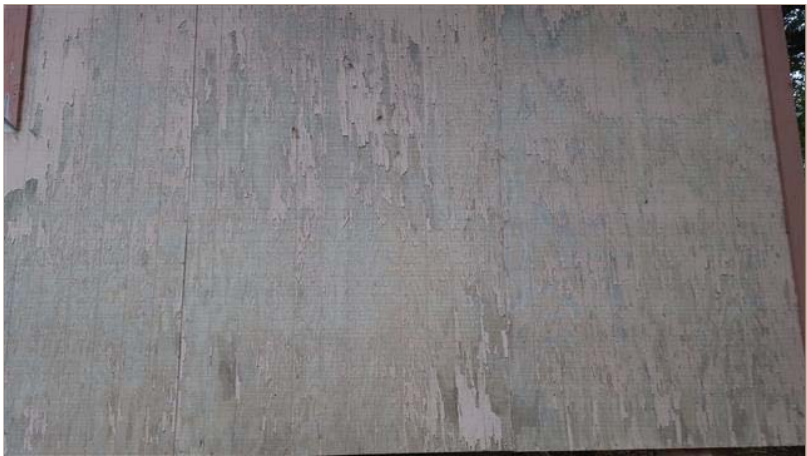
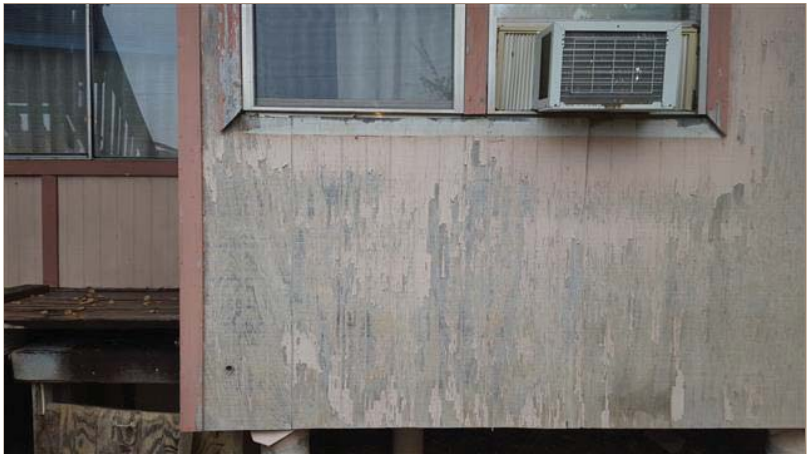
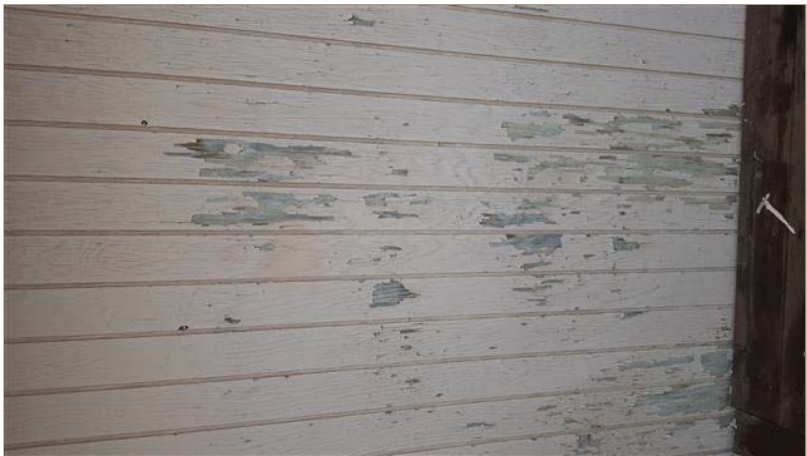
(3) Paint is peeling from exterior walls of the house.

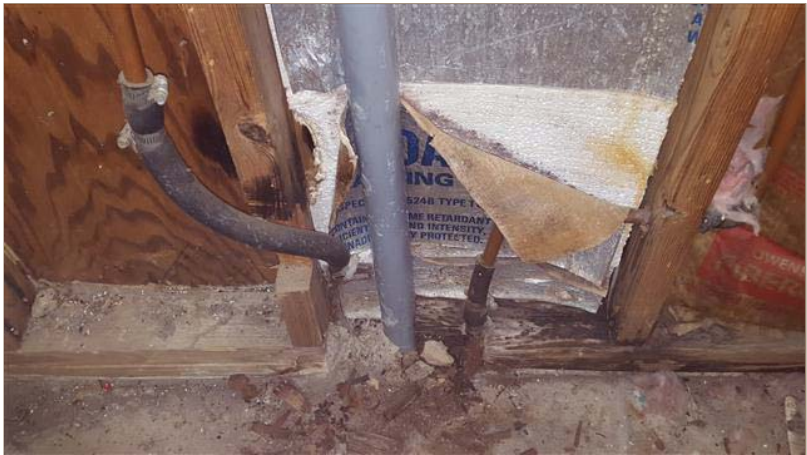
(4) There is water intrusion and wood rot in the laundry room at the washer location.

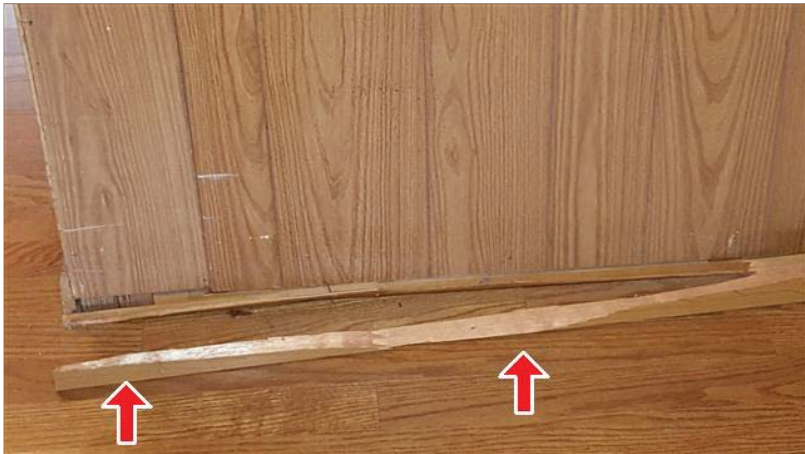
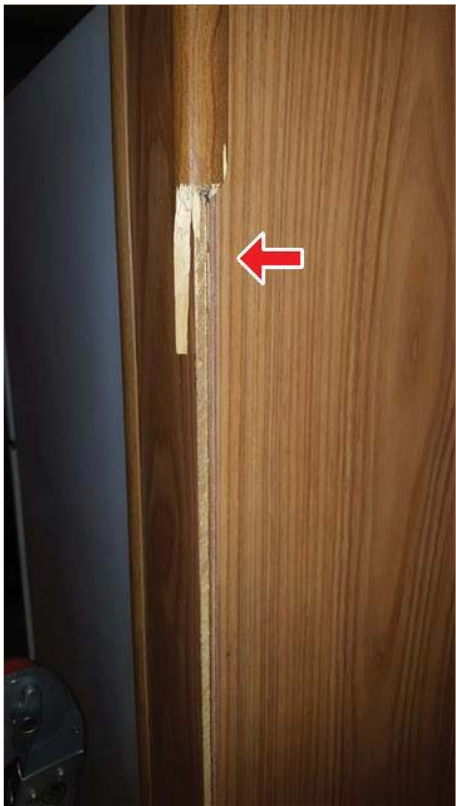
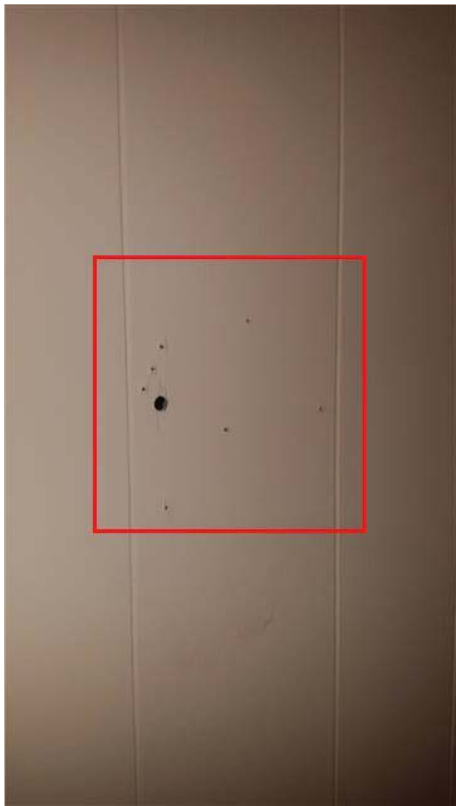
(5) Walls and wall trim damage throughout the house.

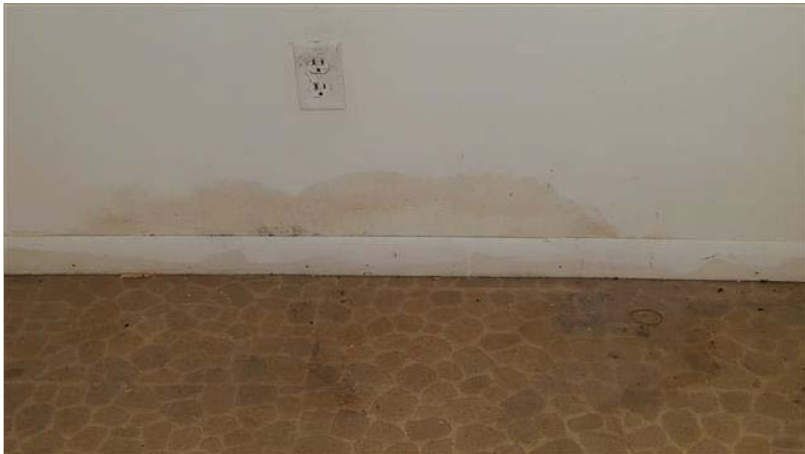
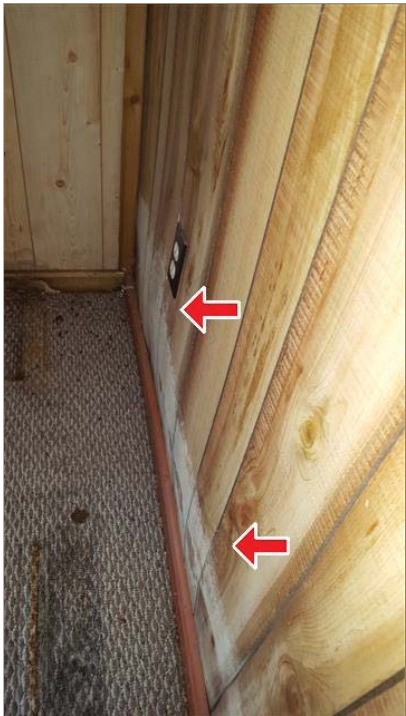
(6) Water damage to walls at back porch addition and garage addition.

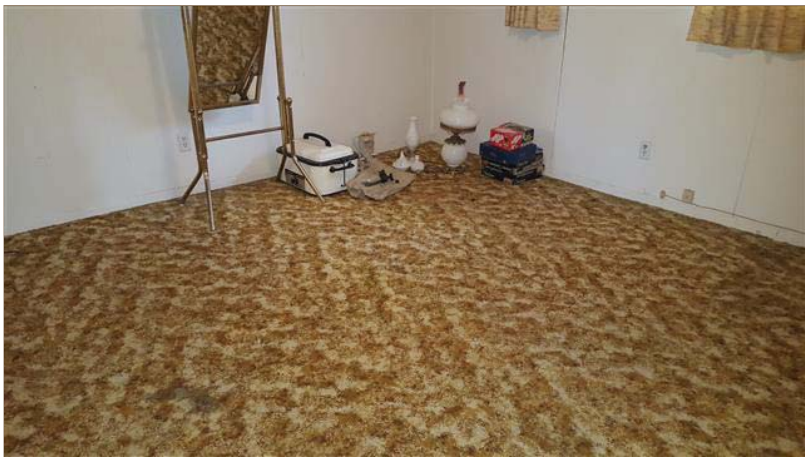
(1) Floor is uplifted in left corner of front bedroom caused by a tree growing to near to the foundation.

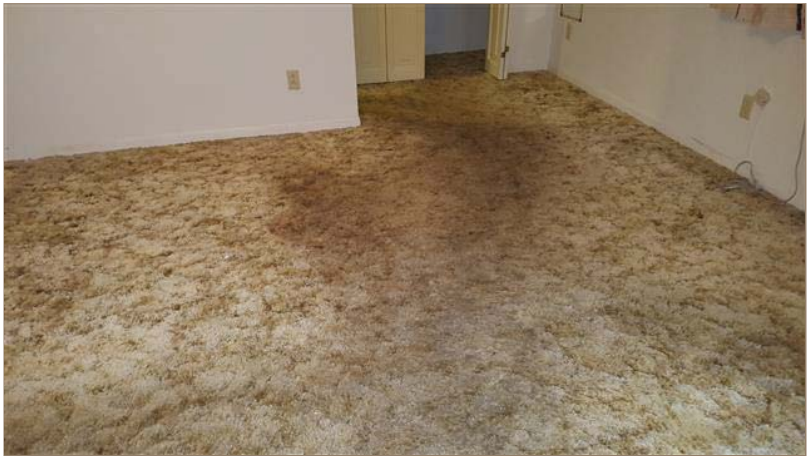
(2) Carpeting in master bedroom is stained and needs to be replaced.

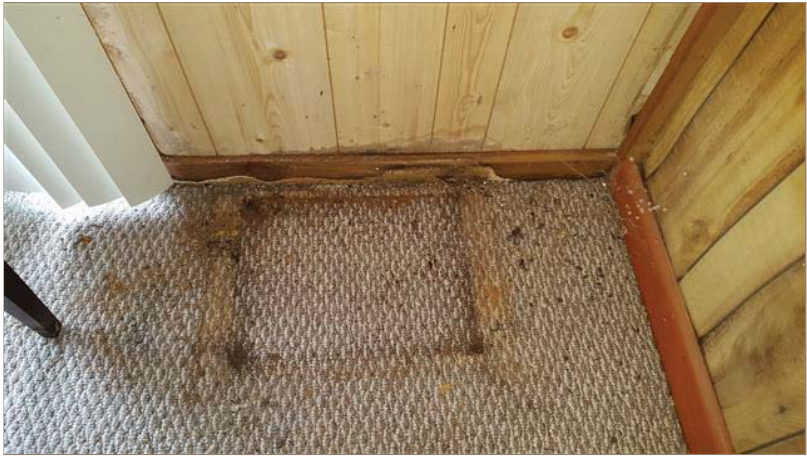
(3) Water damage to floor at garage addition near the sliding glass door.

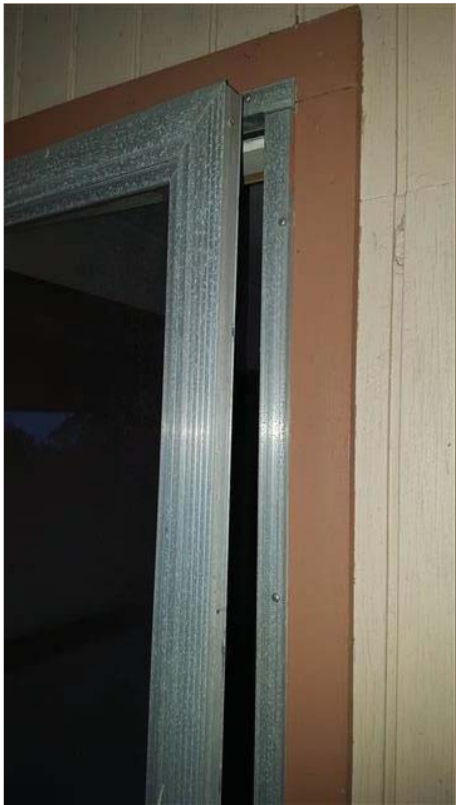
- (1) Storm door at back porch does not close completely and needs to be adjusted.

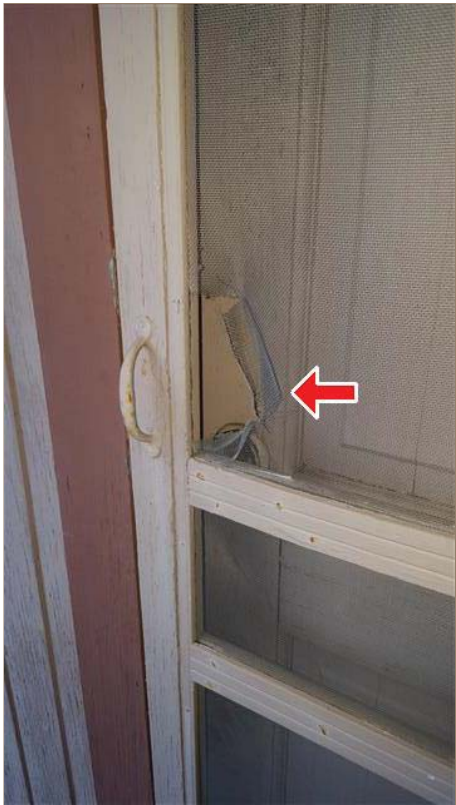
(2) Screen door at back porch is damaged.

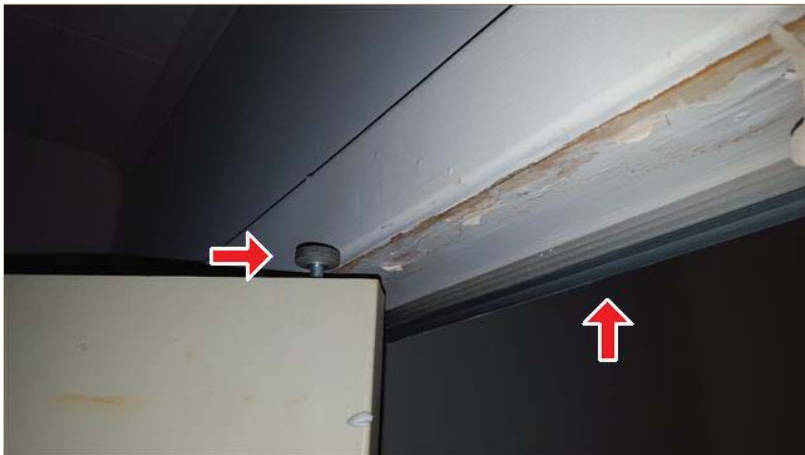
(4) Closet door in master bedroom is off its track.

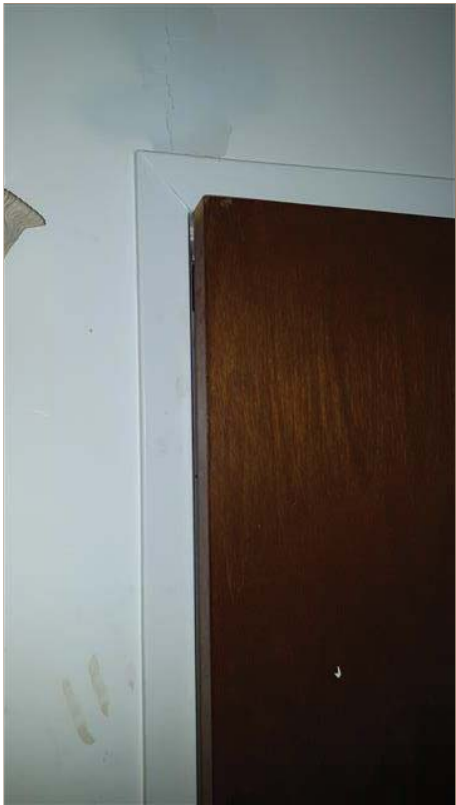
(5) Door at back porch addition sticks and needs to be adjusted to open and close correctly.

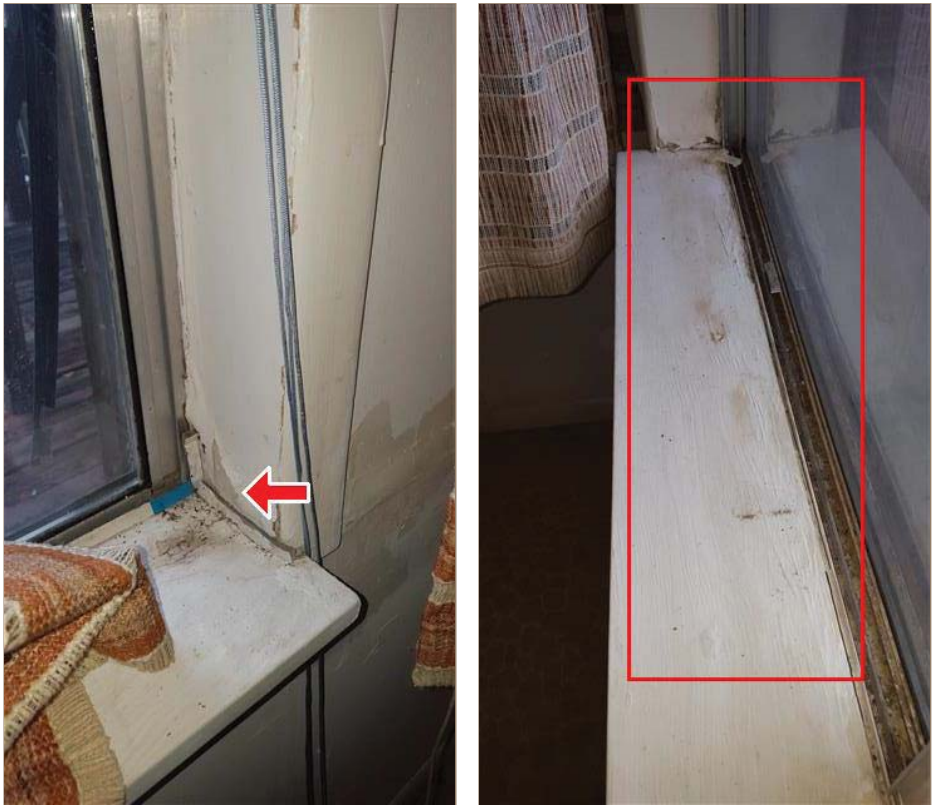
- (1) All windows throughout the house are of single pane glass construction.
- (2) Water intrusion at the back porch addition windows has caused damage to the sills.

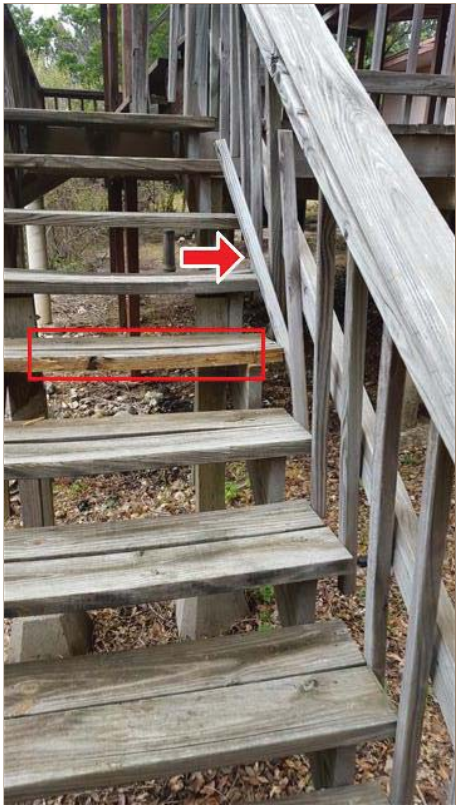
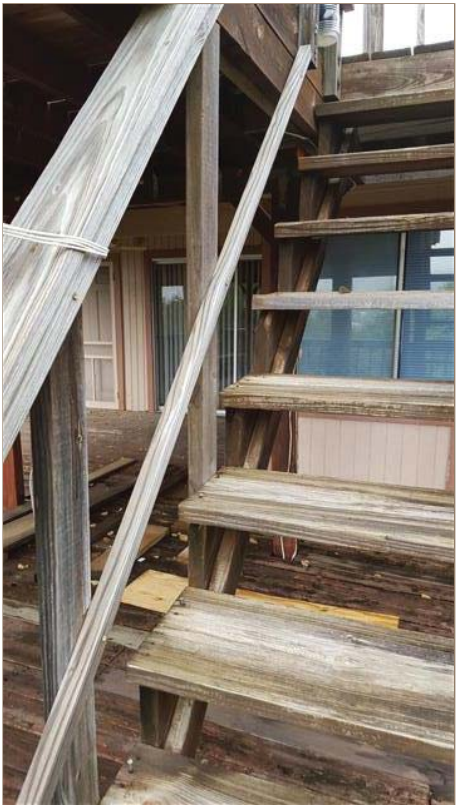
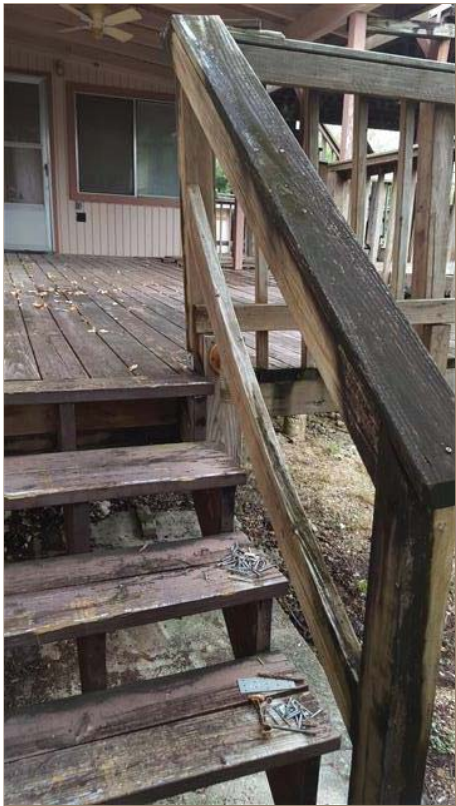
Stairways on the back deck are too narrow, lack proper spacing between balusters and are in need of repair.

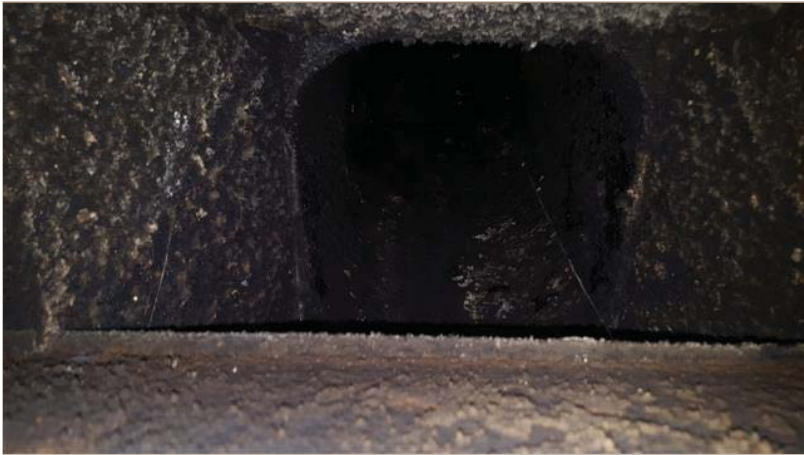
Deficiencies:
(1) Chimney flue is dirty and needs to be cleaned.

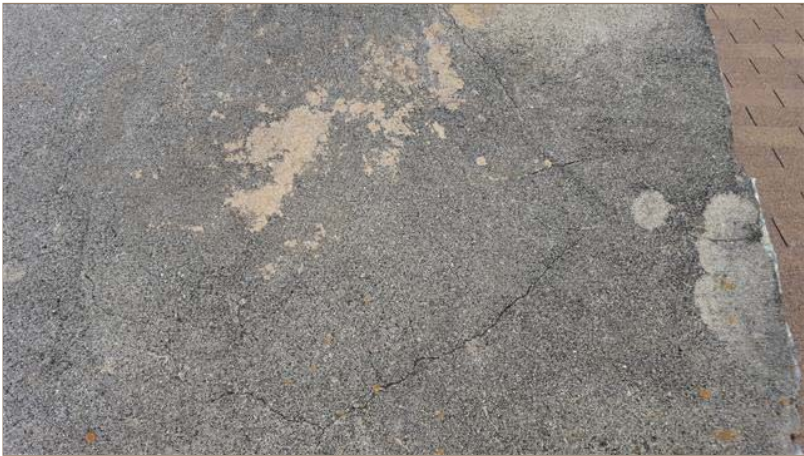
(2) There is no outside combustion air for the fireplace.
(3) Concrete chimney cap has minor cracks in places.

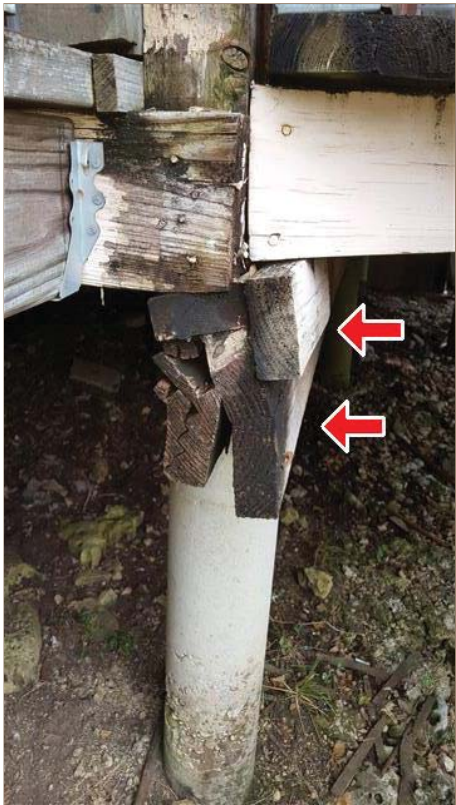
Deficiencies:
(1) Major water damage to support beams under deck. Beams need to be replaced.

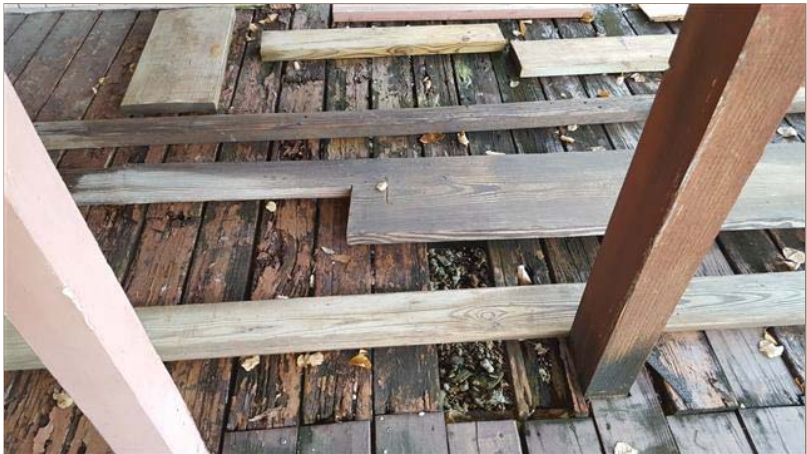
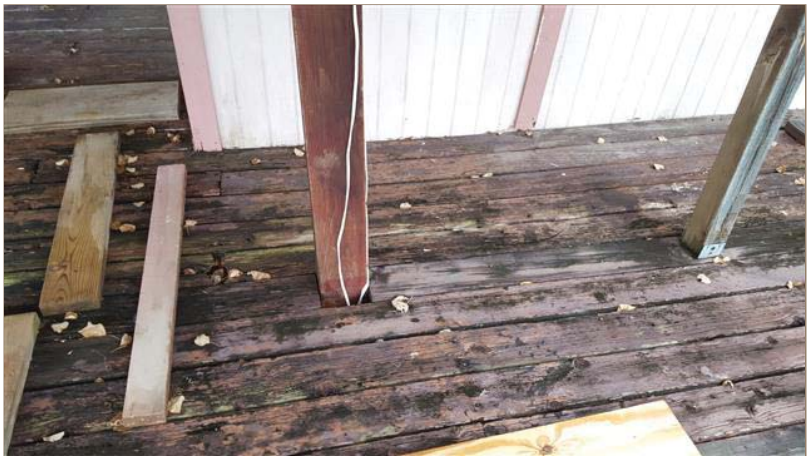
(2) Decking on the bottom deck is rotted through in places and needs to be replaced.

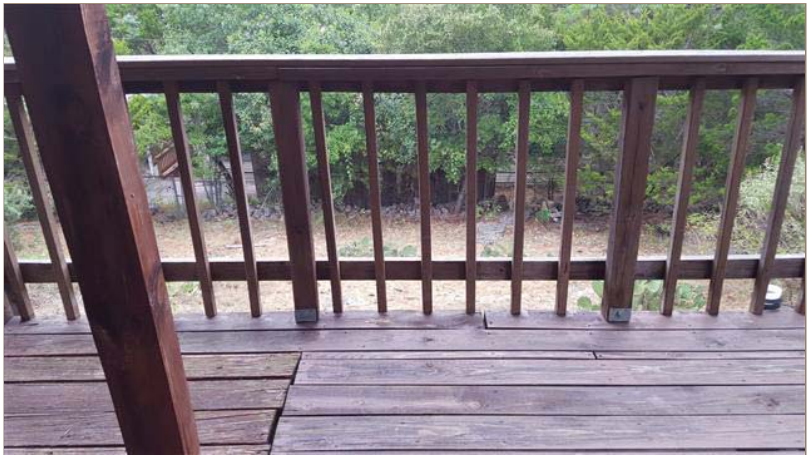
(3) Balusters on deck are spaced too far apart and are a hazard to small children.

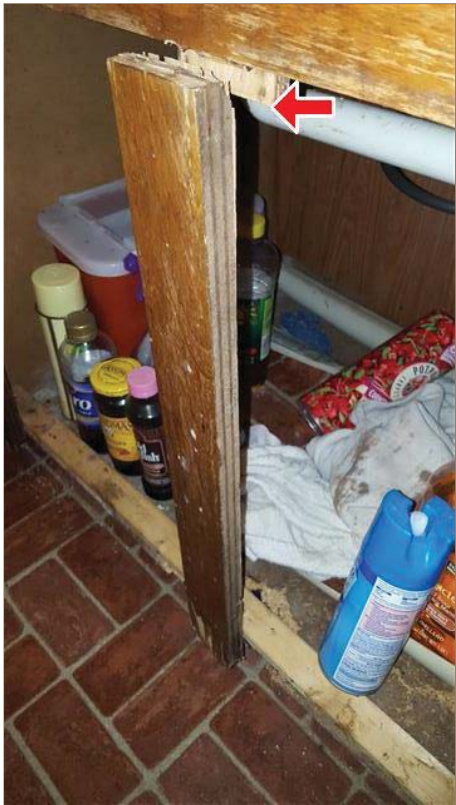
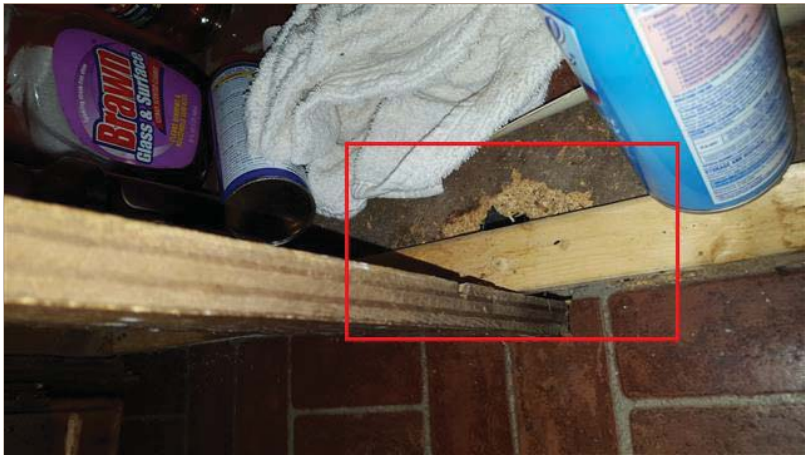
Deficiencies:
Cabinet below kitchen sink is damaged and water damaged.

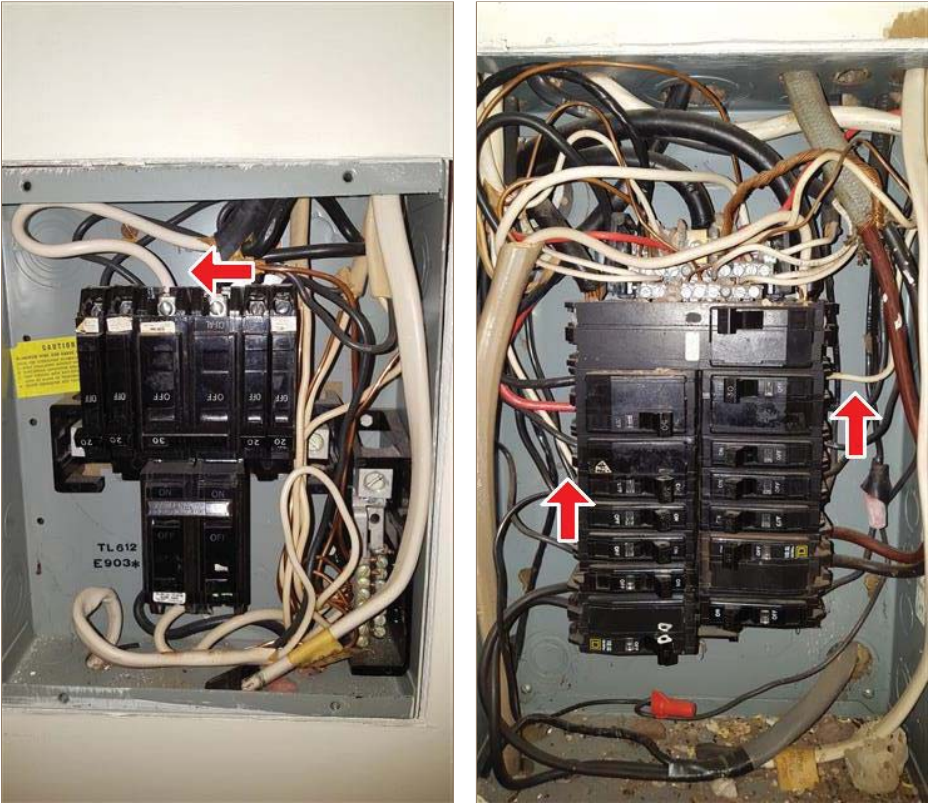
(1) White wire is landed on a circuit breaker and needs to be colored black for proper labeling purposes.

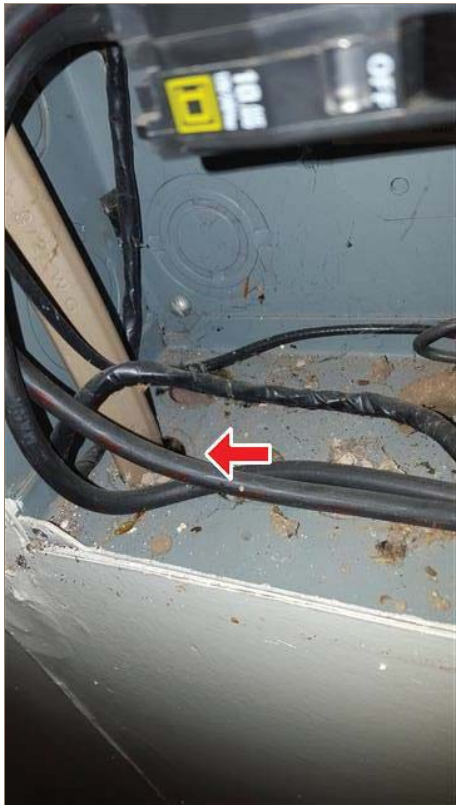
(2) Romex connector missing from wire at box entrance.

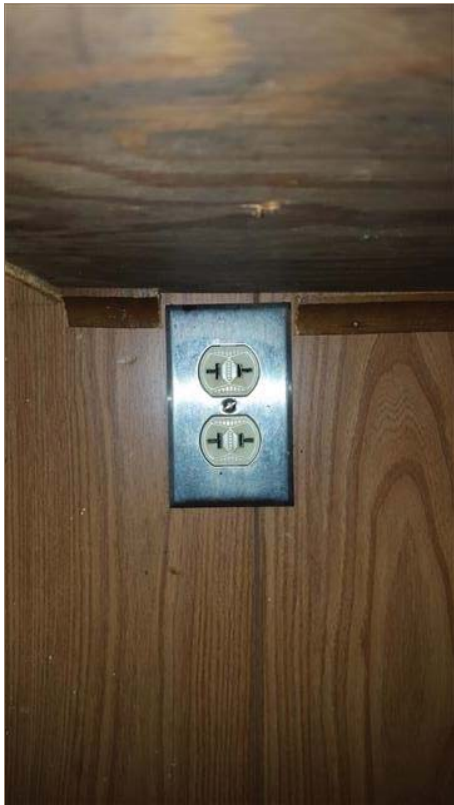
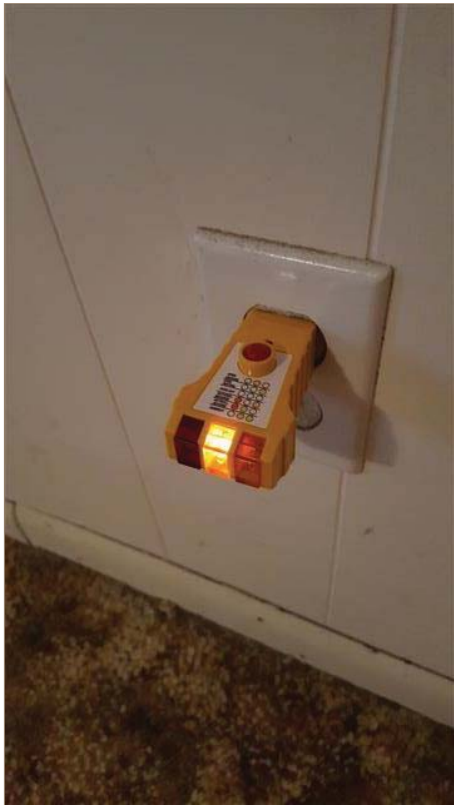
(1) Ungrounded two wire electrical system throughout the main portion of the house. **Recommend a licensed electrician evaluate and make necessary repairs.**

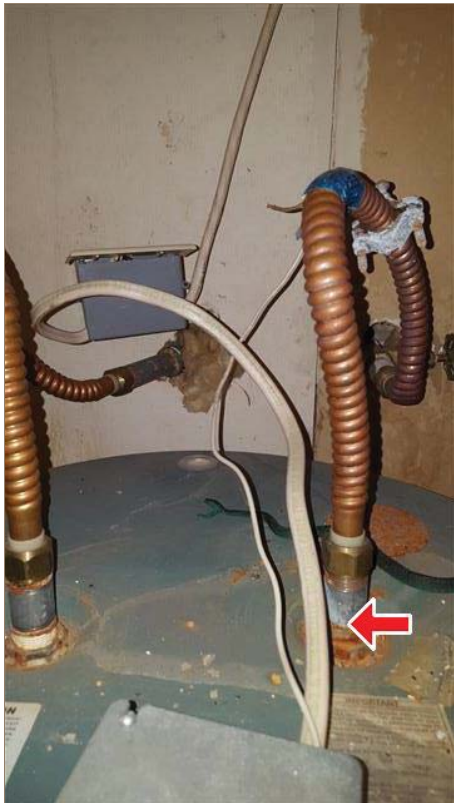
(2) Romex wire supplying power to the water heater should be run in flexible conduit.

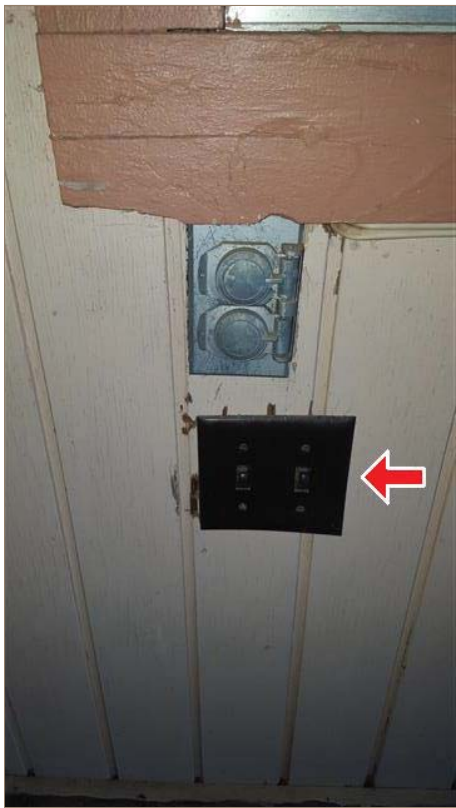
(3) Light switches on the back porch are not rated for exterior use.

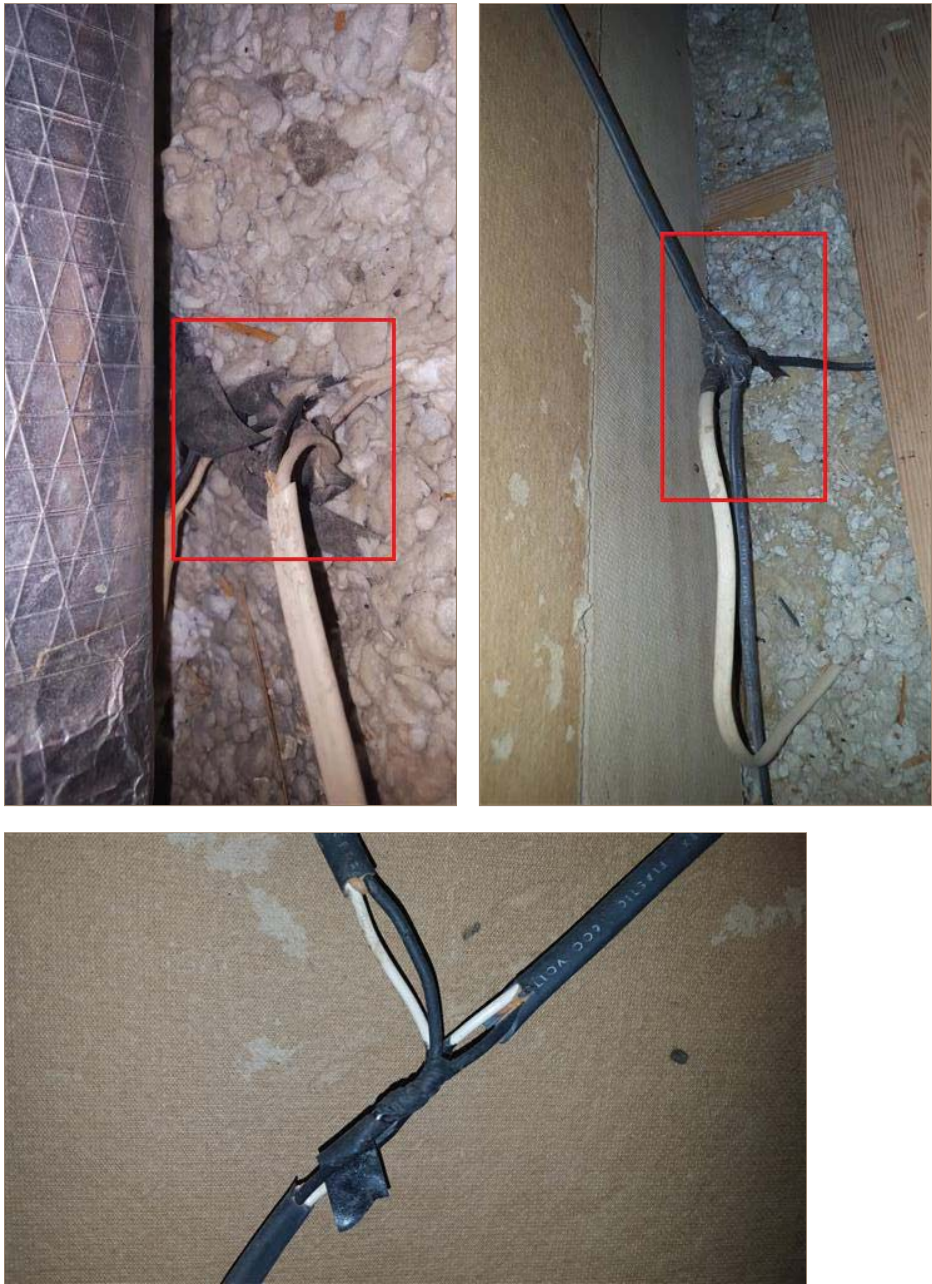
(4) Spliced wires in the attic should be in a junction box.

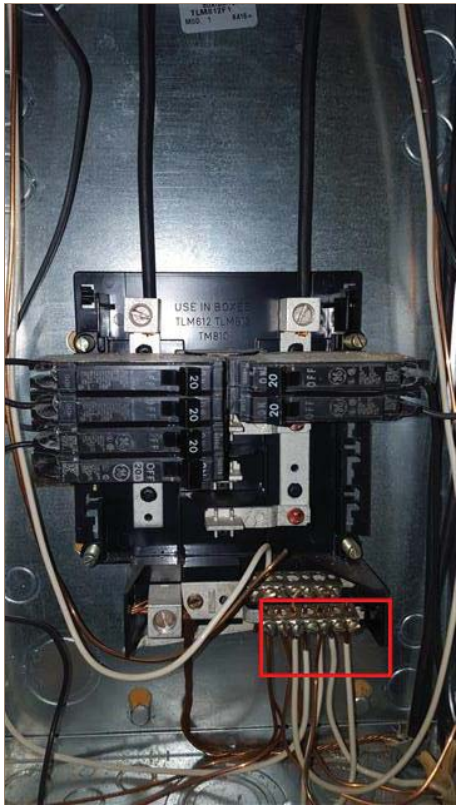
(5) Ground and neutral wires are landed on the same bus bar. Ground wires need to be removed to eliminate the possibility of the return path for electric current to be along a ground wire.

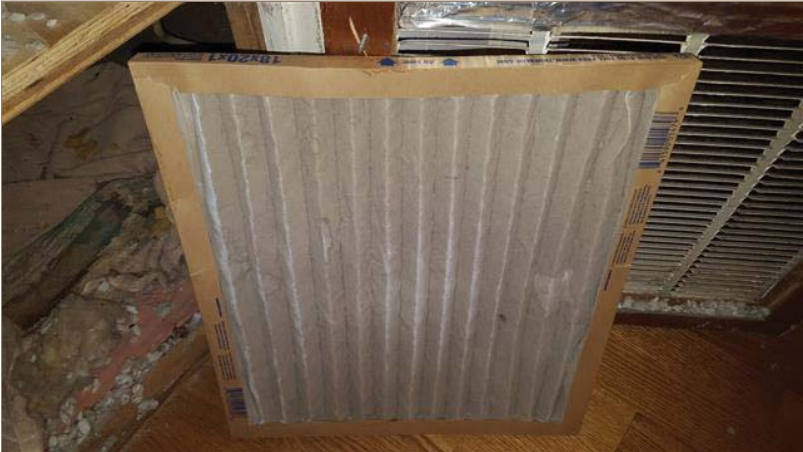
Air conditioning filter is dirty and is the wrong size. It should be a 20 X 20 filter.

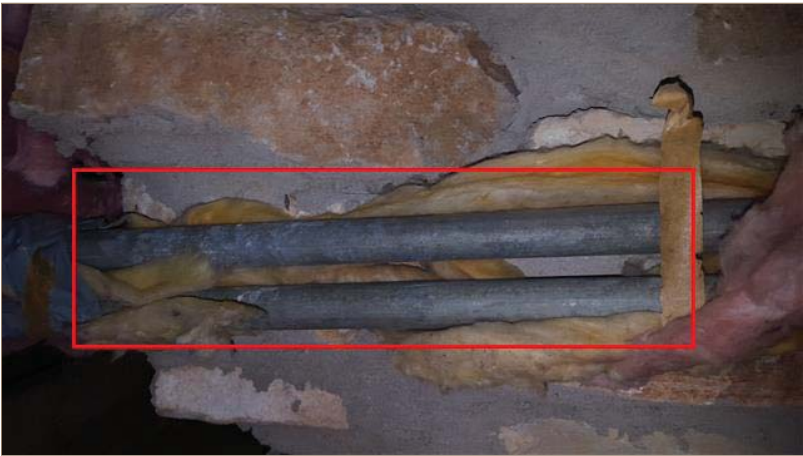
(1) Plumbing supply pipes are of galvanized steel construction which corrode over time. **Recommend a licensed plumber evaluate and make necessary repairs.**

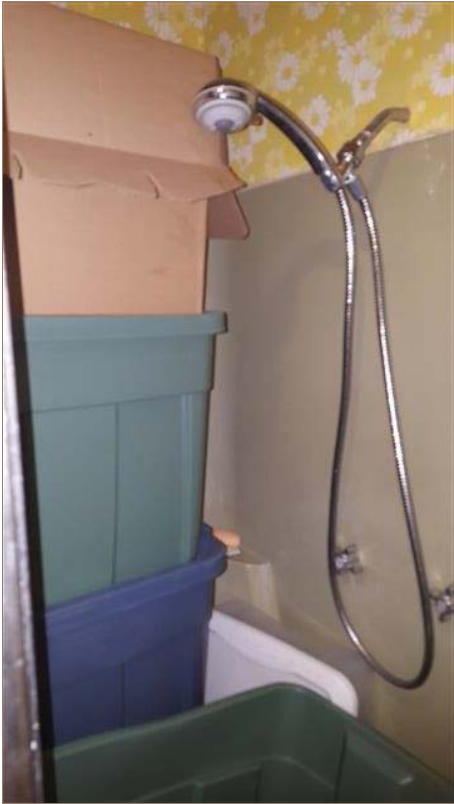
(4) I could not check the functioning of the master bath shower due to storage of items.
