Inspection Report

111 Sample Dr.
Anytown, TX

JMJ Home Inspections

Date: 7/21/2015	Time: 9:00 AM	Report ID: Sample
Property: 111 Sample Dr. Canyon Lake TX	Customer: Joe Homebuyer	Real Estate Professional: Mary Realtor

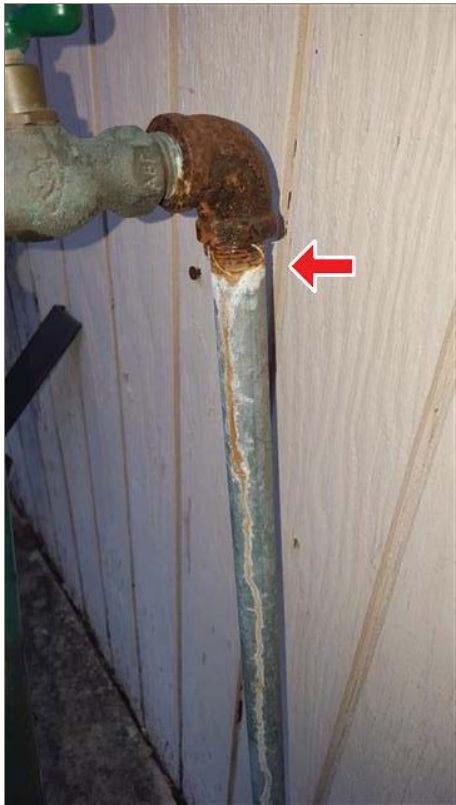
(5) Galvanized water pipe corroded at front porch hose bib.

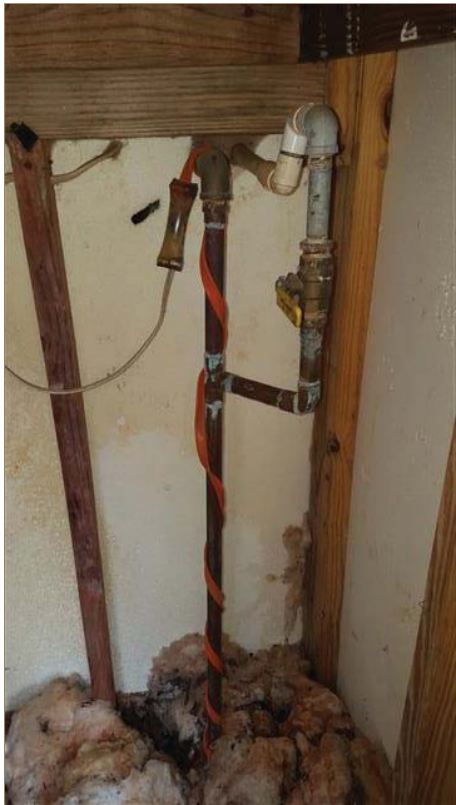
(6) Water intrusion at the main water entrance to the house. Piping should be insulated to keep from freezing in cold weather.

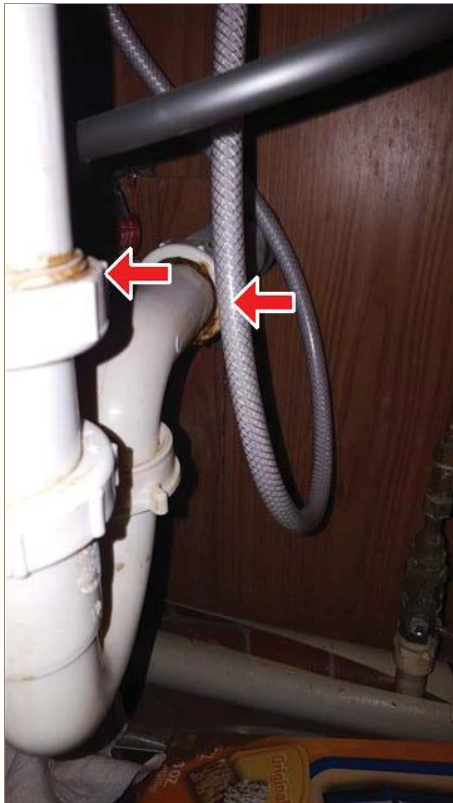
Corrosion of plumbing lines under kitchen sink.

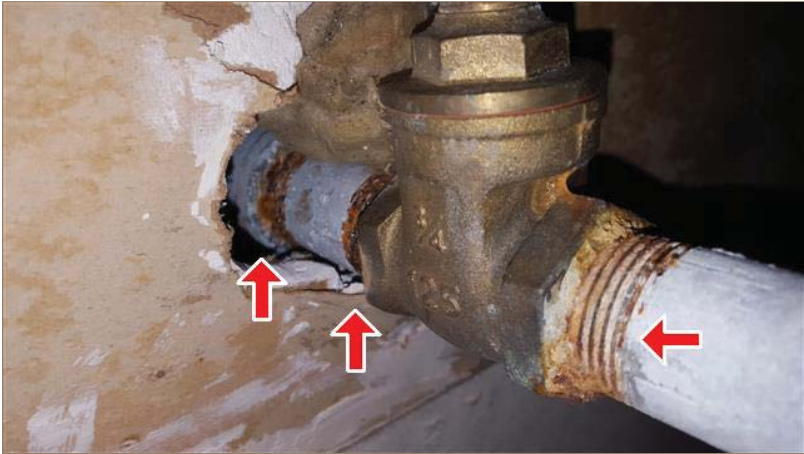
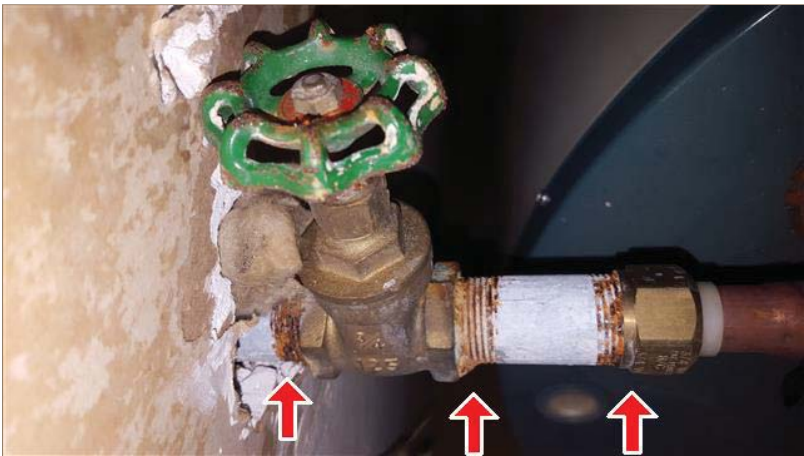
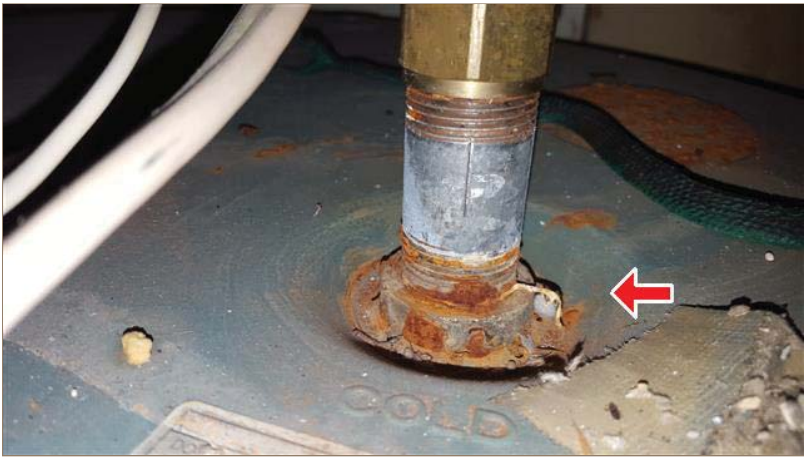
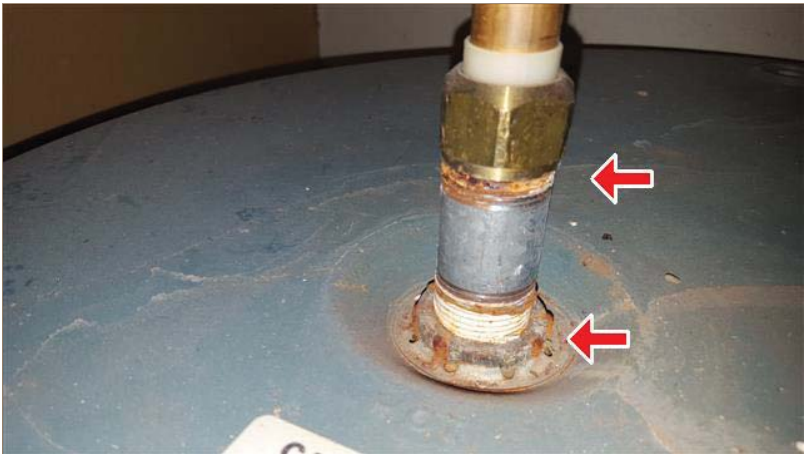
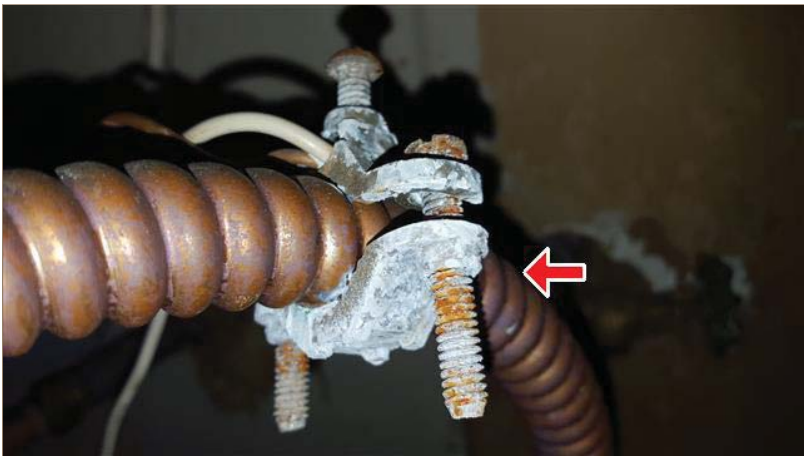
(1) Most fittings on the water heater are corroded. **Recommend a licensed plumber evaluate and make necessary repairs.**

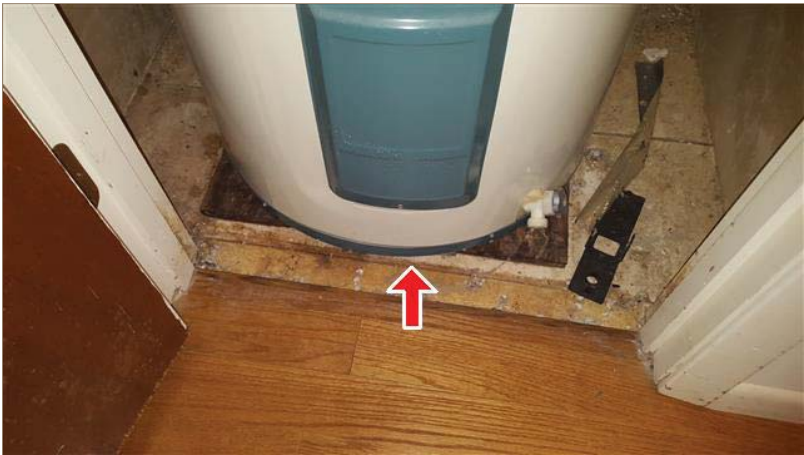
(2) Secondary drain pan missing from water heater.

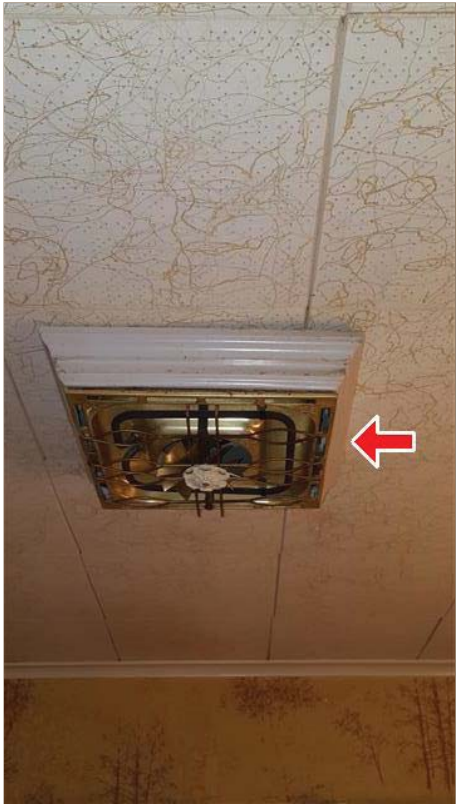
- ☐☐☒☐ A. Dishwashers
Deficiencies:
- ☐☐☒☐ B. Food Waste Disposers
Deficiencies:
- ☒☐☐☐ C. Range Hood and Exhaust Systems
Exhaust/Range hood: Montgomery Ward
Serial #: Montgomery Ward
Deficiencies:
- ☒☐☐☒ D. Ranges, Cooktops and Ovens
Range/Oven: General Electric
Deficiencies:
Anti-tip bracket missing from range.
- ☐☐☒☐ E. Microwave Ovens
Deficiencies:
- ☒☐☐☒ F. Mechanical Exhaust Vents and Bathroom Heaters
Deficiencies:
Heater in front bathroom does not work.

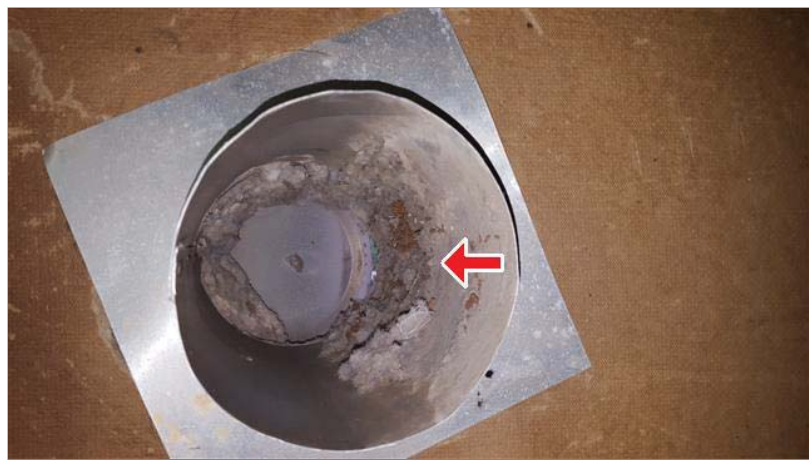
Deficiencies:
Dryer vent needs to be cleaned.
