Inspection Report

111 Sample Dr.
Anytown, TX

JMJ Home Inspections

Date: 7/21/2015	Time: 9:00 AM	Report ID: Sample
Property: 111 Sample Dr. Canyon Lake TX	Customer: Joe Homebuyer	Real Estate Professional: Mary Realtor

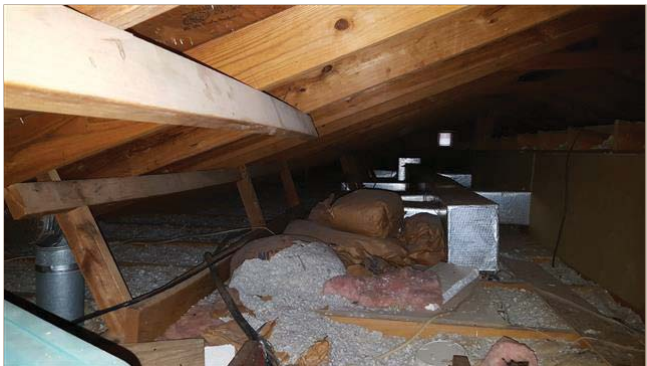
(4) Less than 6 inches of insulation in the attic. Recommend adding additional insulation to help with energy efficiency of the home.

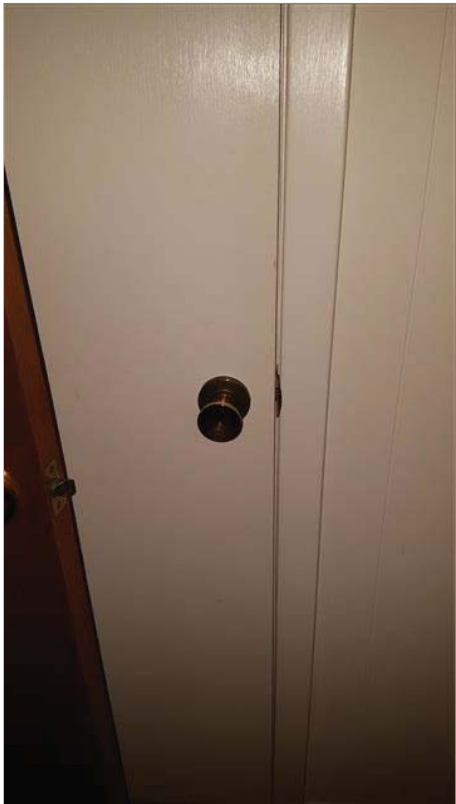
(3) Closet door in front bedroom does not latch and needs to be adjusted.

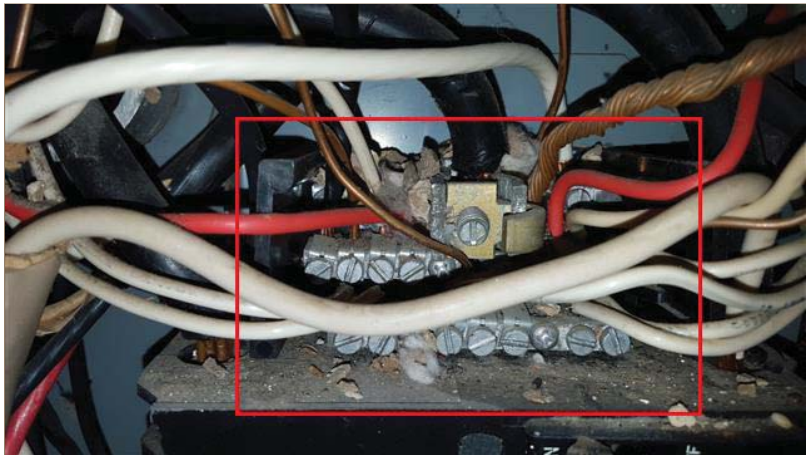
(3) Ground and neutral wires are landed on the same bus bar. Ground wires need to be removed to eliminate the possibility of the return path for electric current to be along a ground wire.
